Manhole Inspection Summary

Manhole # S25QQ1005MH

Insp Date: **8/18/08 11:27 AM**

Location Address: **4708 ROLAND AVE**

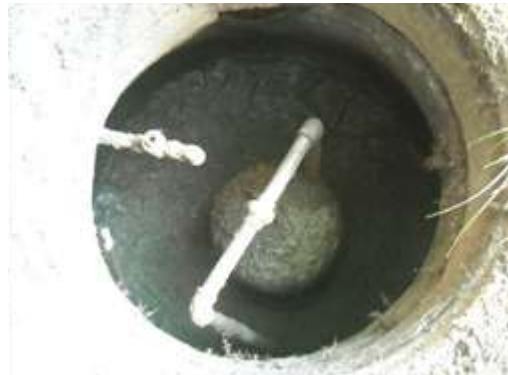
Top View

Channel debris.

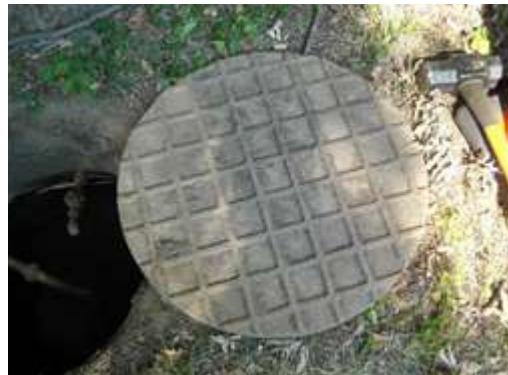
Lid

No pick holes.

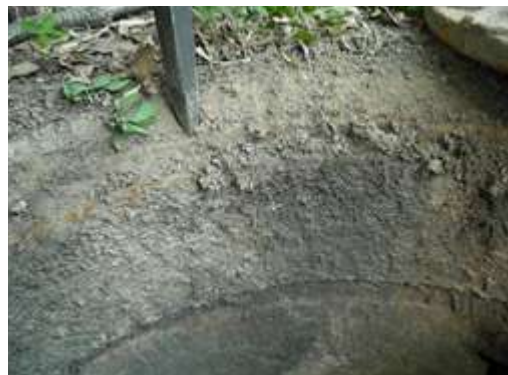
Defect

Below grade.

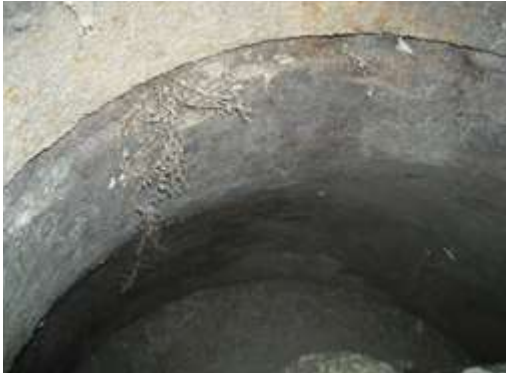
Defect

Frame leaks. Corbel root intrusion and infiltration.

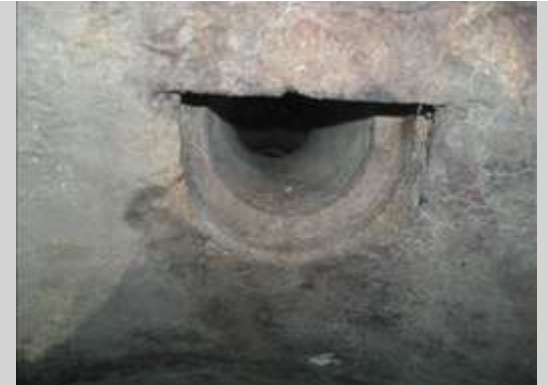
6 in. Circular Gravity Sewer
Pipe Out @ 12 O'Clock

Infiltration: **None** Pipe Seal Cond: **Unknown**
